Urban
fountains + furniture

Drinking Fountains

Models: CF200

INSTALLATION, OPERATION AND MAINTENANCE INSTRUCTIONS

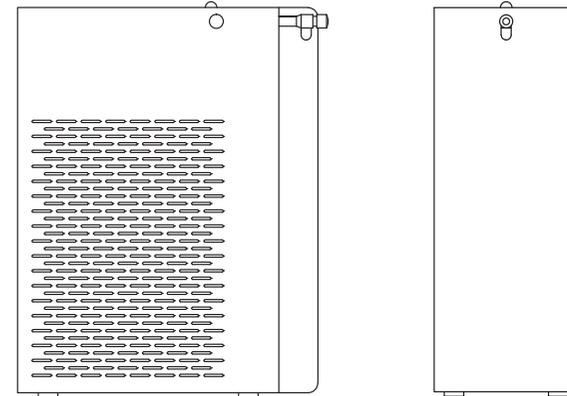
- ▶ 1/2" bsb water inlet (15mm)
 - ▶ 40mm waste outlet
 - ▶ Chilling capacity 30 litres per hour
 - ▶ 600kpa Water Pressure Reducer installed
 - ▶ Access to electrical power required
 - ▶ Earthing points provided
 - ▶ 240 Volts, 50Hz Full load current is 4.8amps
- Install to AS300 Regulations
